Delaware's Inland Bays Seagrass Reestablishment Project

SAV as an Environmental Indicator

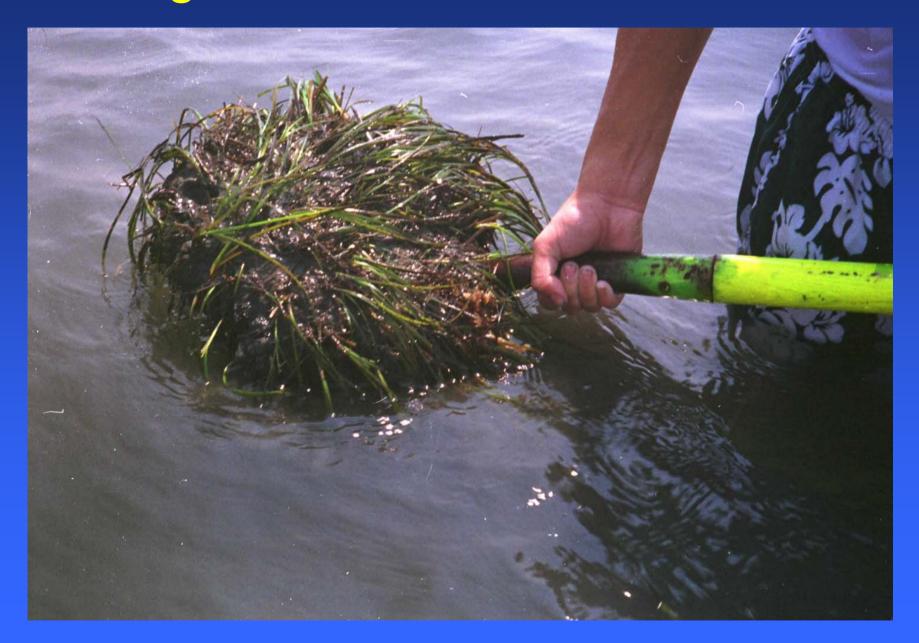
#### **Eelgrass Harvested from Beds**

- 1-Collect eelgrass in Chincoteaque
- 2-Assemble eelgrass plants into planting bundle
- 3- Assemble dive teams to plant in Inland Bays

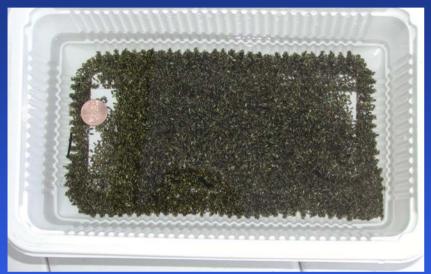
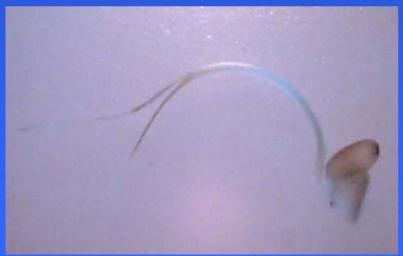
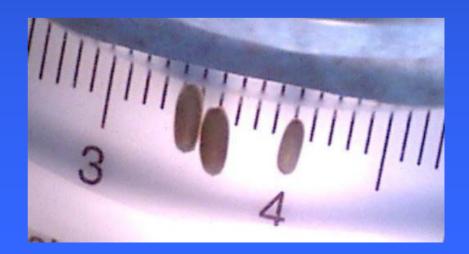
## 2003 SAV Pilot Project Seeds to Augment Transplanting

- Less labor intensive
- No permits required
- Proven technique
- Requires large indoor tanks-1,000 gals.

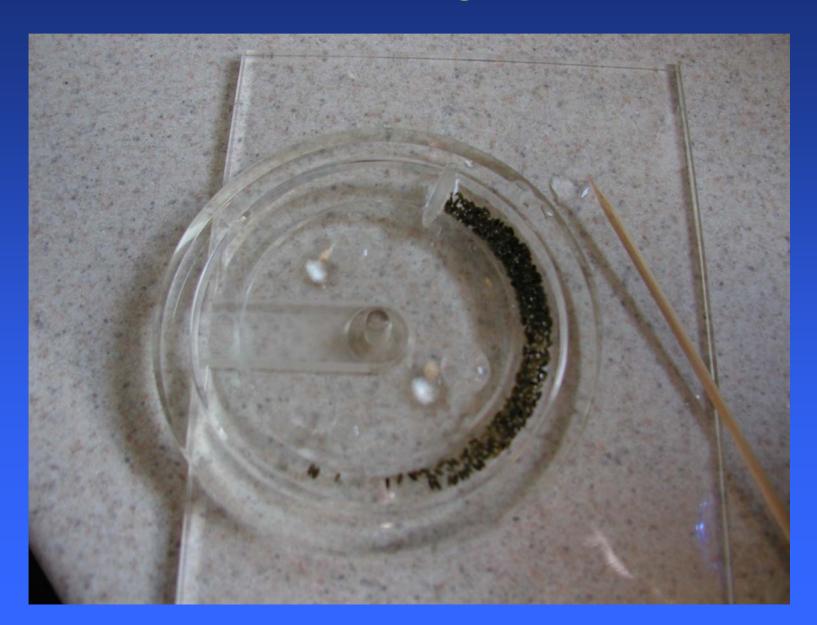
# Plankton Counting Wheel

1ml=
66
Zm
seeds
