THE STATE OF YOUR CREEK

Dirickson Creek on Little Assawoman Bay

The State of Your Creek: Dirickson Creek on Little Assawoman Bay

Andrew McGowan, Marianne Walch, and Sally Boswell
Delaware Center for the Inland Bays

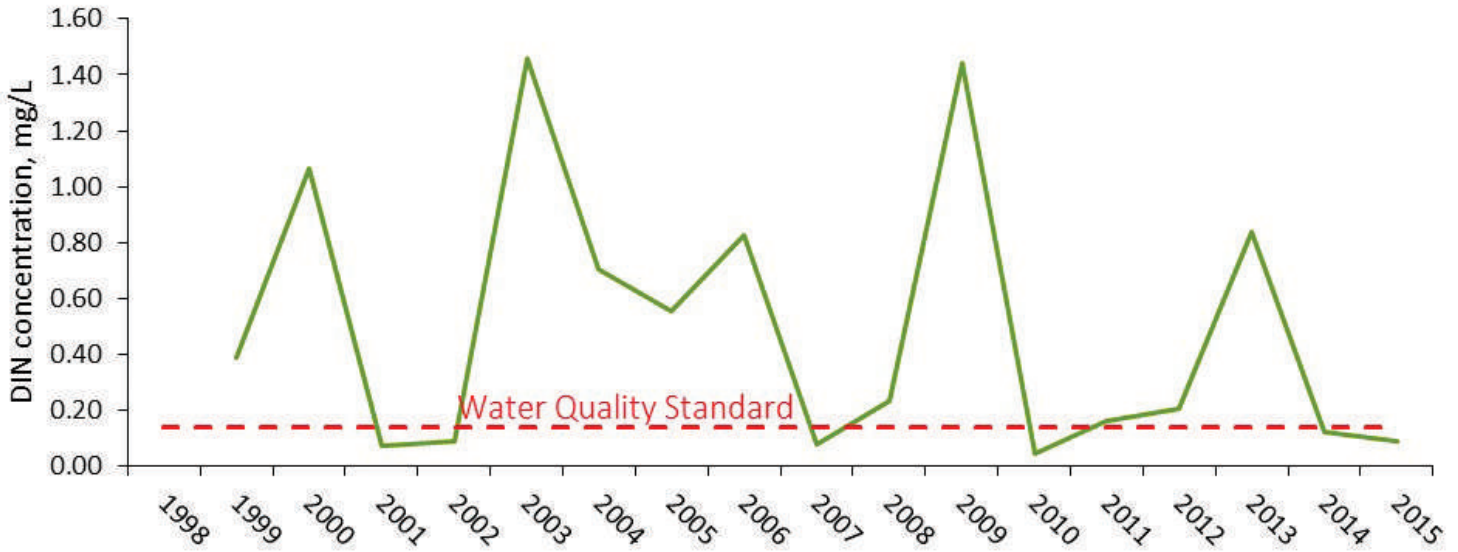
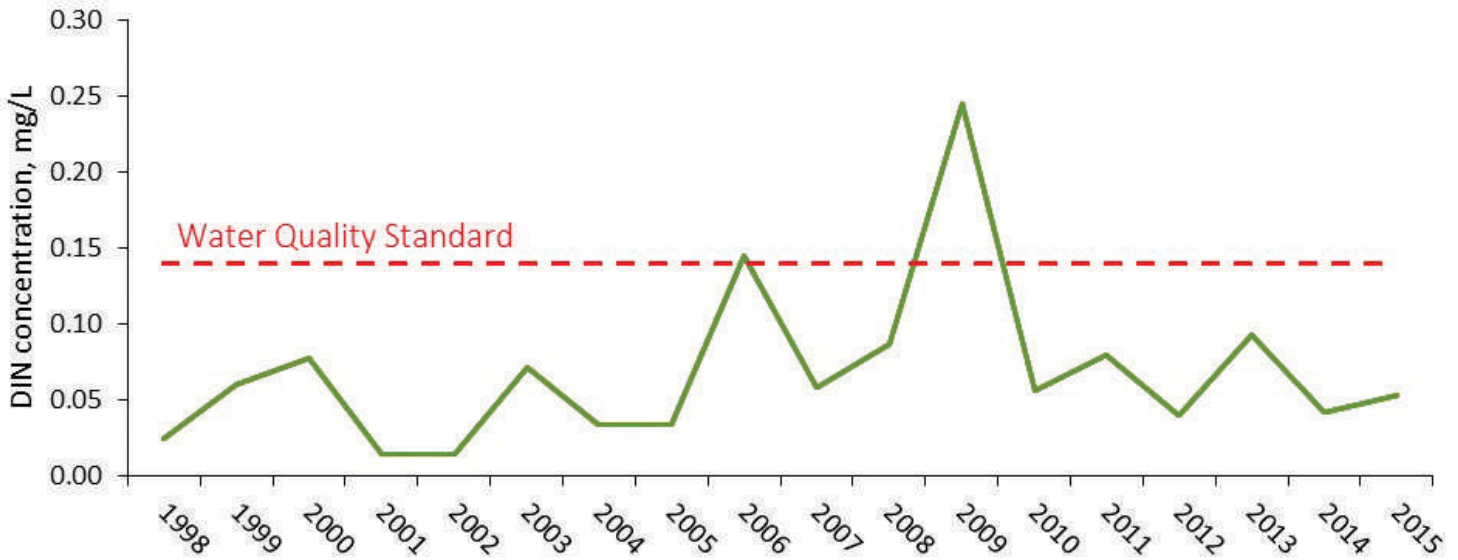
Median Nitrogen Concentration Station LA09 - Old Mill Road Bridge

Figure 12. Median annual concentrations of dissolved inorganic nitrogen (DIN) measured by the Old Mill Road bridge (Station LA09) and further downstream at Mulberry Landing (Station LA03). The state water quality standard for DIN, 0.14 mg/L, is indicated by the dashed red line. (Data Source: University of Delaware Citizen Monitoring Program)

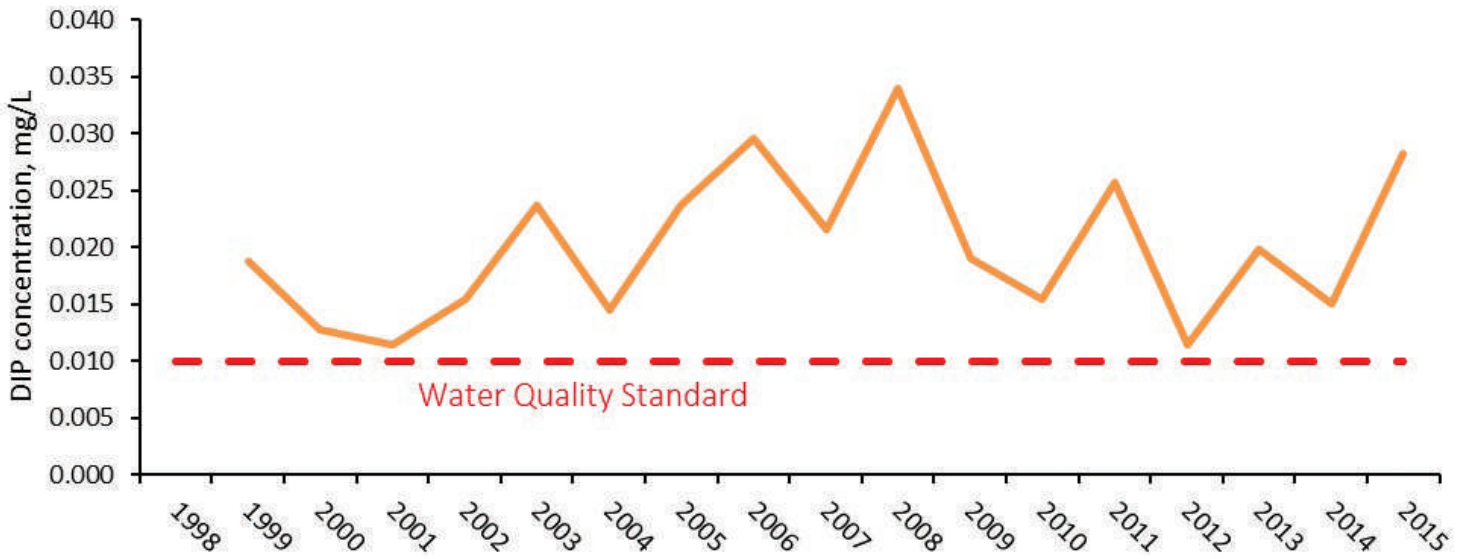
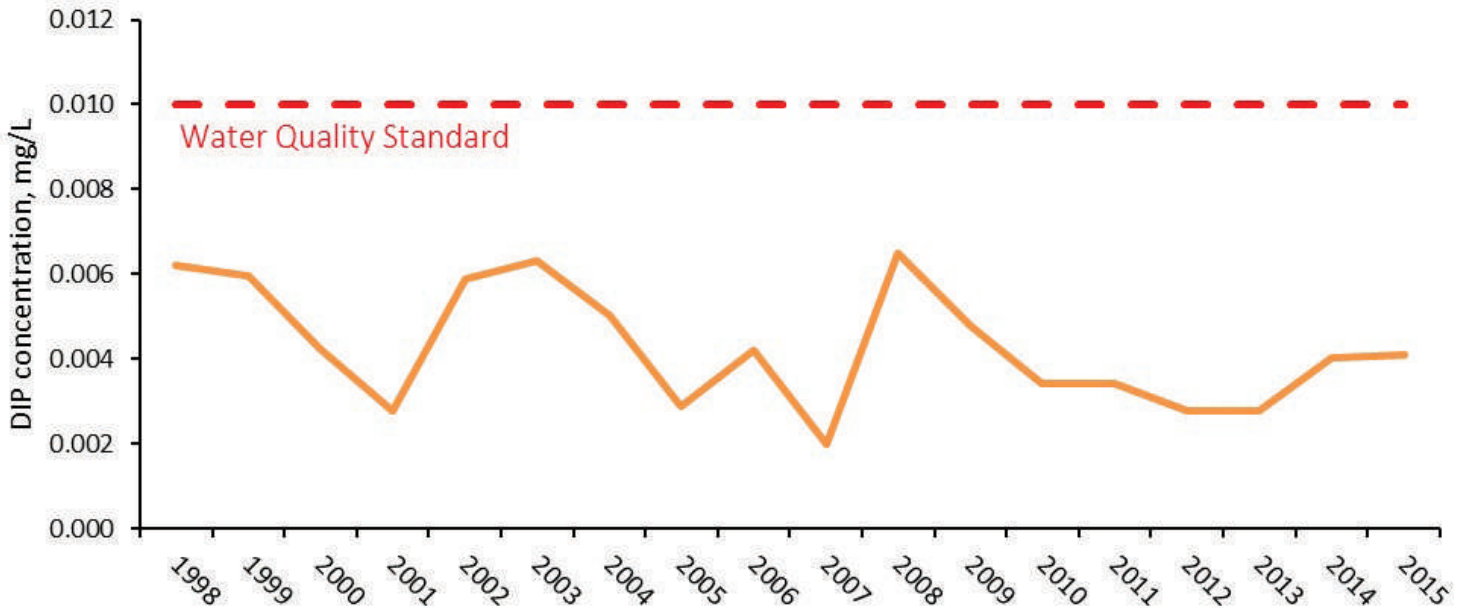
Median Phosphorus Concentration Station LA09 - Old Mill Road Bridge

Figure 13. Median annual concentrations of dissolved inorganic phosphorus (DIP) measured by the Old Mill Road bridge (Station LA09) and further downstream at Mulberry Landing (Station LA03). The state water quality standard for DIP, 0.01 mg/L, is indicated by the dashed red line. (Data Source: University of Delaware Citizen Monitoring Program)

Phosphorus concentrations in Dirickson Creek follow a pattern similar to that for nitrogen (Figure 13). Median concentrations of phosphorous at the upstream monitoring station have consistently failed to meet the water quality standard, and show no overall trend over time.

At the station downstream of Mulberry Landing, however, phosphorus concentrations do meet the water quality standard. Again, this reflects a pattern typical in the Inland Bays that was revealed in the 2016 State of the Delaware Inland Bays report. While water quality improvements over time have been observed in open waters of the Bays, the tributaries and canals continue to have poorer water quality, algae blooms, and unhealthy oxygen concentrations due to their proximity to nonpoint sources and poor tidal flushing.

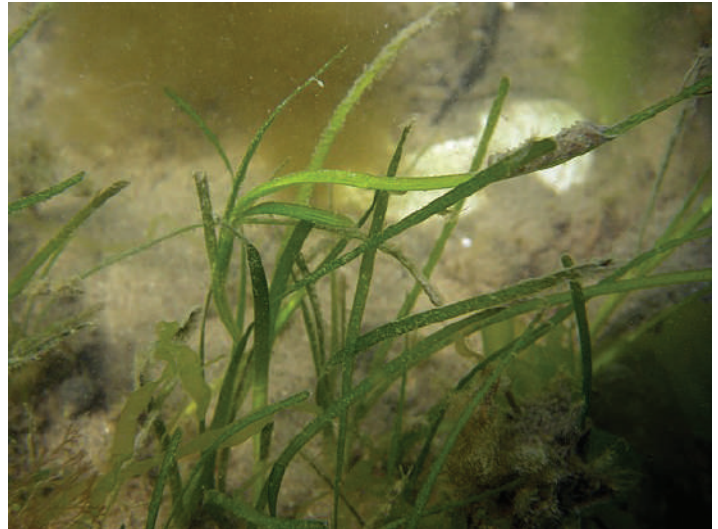
Figure 14. Submerged eelgrass (*Zostera marina*).

Eelgrass (*Zostera marina*) is one of the most valued species of baygrasses (Figure 14). By the late 1970s, eelgrass and most other baygrass species had disappeared from the Inland Bays, due to disease and increasing nutrients. When it seemed that water quality might be improving in the 1990s, some attempts were made to reestablish eelgrass in parts of the Inland Bays. However, nutrient concentrations were still too high for eelgrass survival in much of the Bays, and macroalgae such as sea lettuce, smothered restoration attempts. Eelgrass grows in firm sandy substrates, and primarily in medium to high salinity waters. Due to restricted flushing between Dirickson Creek and the Ocean City Inlet, Dirickson Creek experiences large fluctuations in salinity, ranging from fresh to high salinity depending on the amount of rainfall. Along with these fluctuations, Dirickson Creek primarily has a soft sediment bottom. These physical factors make Dirickson Creek an unlikely environment for eelgrass to grow and thrive in.

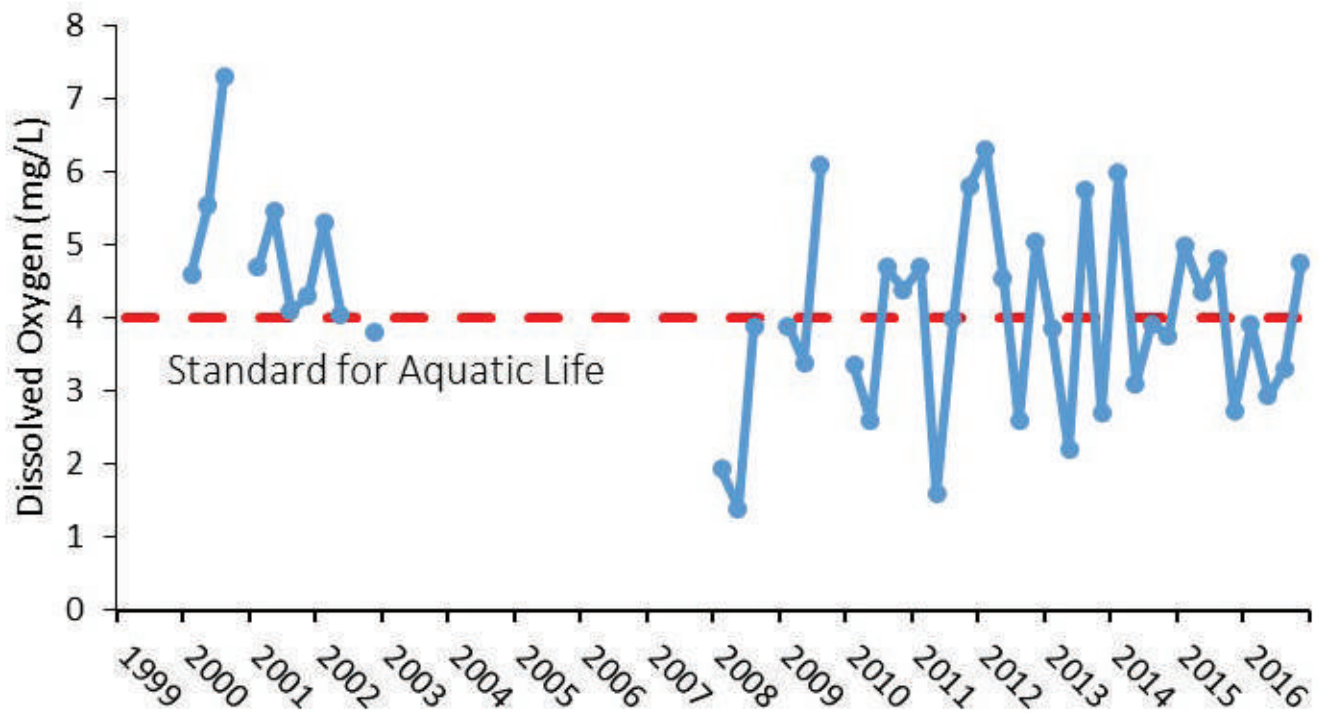
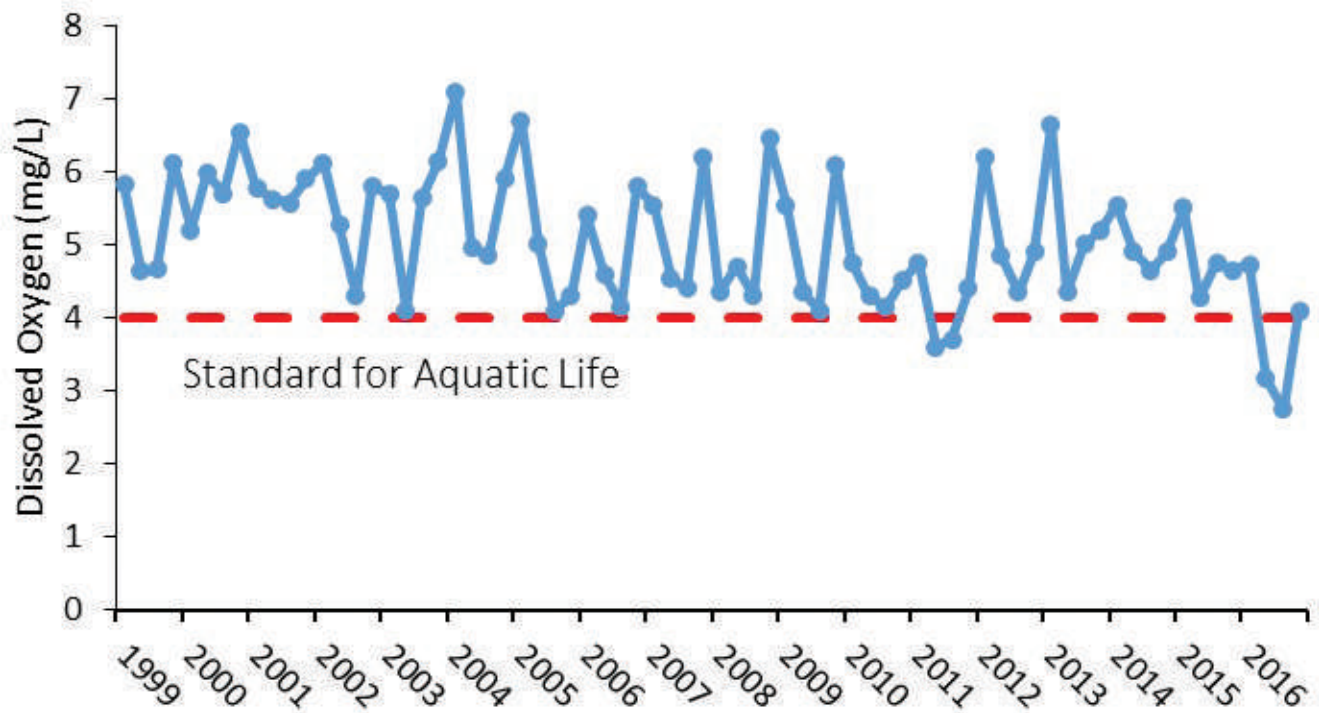
Station LA09 - Old Mill Road Bridge

Figure 16. Monthly mean dissolved oxygen concentrations measured on summer mornings by the Old Mill Road bridge (Station LA09) and further downstream at Mulberry Landing (Station LA03). The DO standard to support aquatic life is indicated by the red dashed line (4.0 mg/L). (Data Source: University of Delaware Citizen Monitoring Program)

Between 1999 and 2016 at the Old Mill Road Bridge station, 45 percent of the observed summer months had mean dissolved oxygen values below the water quality standard of 4 mg/L (Figure 16). At Mulberry Landing, only 5% of the summer months had mean values that failed to meet the dissolved oxygen standard. This difference is due largely to increased tidal flushing at the creek mouth and lower nutrient concentrations compared to the Old Mill Road bridge station.

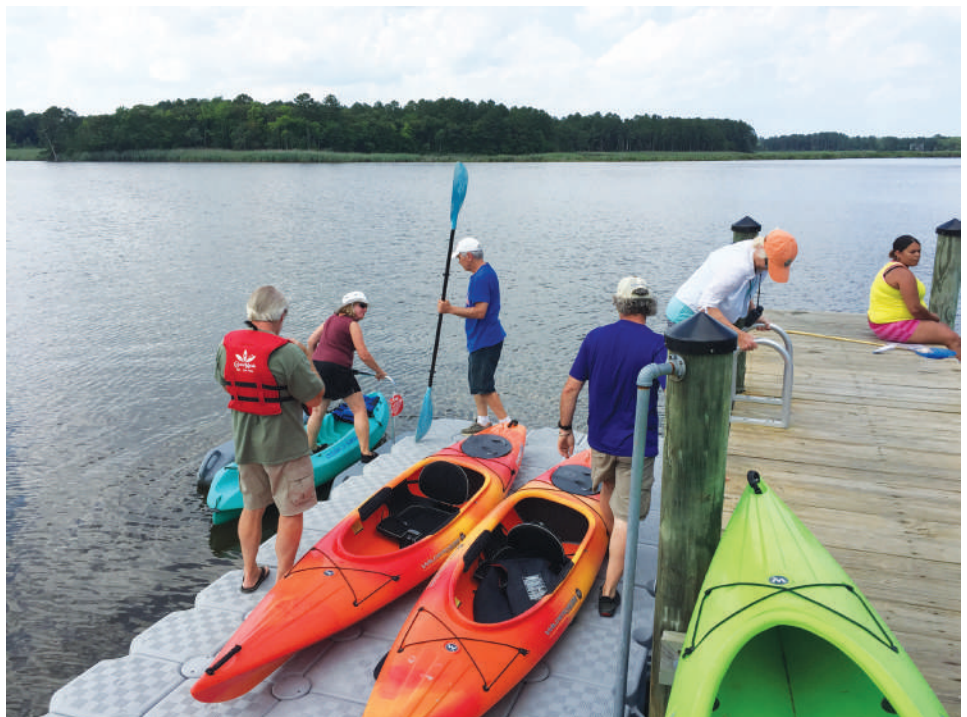
Enterococcus Bacteria, Summer Means
Station LA09 - Old Mill Rd Bridge

Figure 17. Average summertime concentrations of Enterococcus indicator bacteria measured by the Old Mill Road bridge (Station LA09) and further downstream at Mulberry Landing (Station LA03). The long term safe swimming standard for Enterococcus, 35 colony forming units (cfu) per 100 milliliters, is indicated by the dashed red line. (Data Source: University of Delaware Citizen Monitoring Program)

Upstream, at the Old Mill Road bridge monitoring station, summertime *Enterococcus* concentrations failed to meet the single-sample safe swimming standard of 104 CFU/100 mL nearly 80% of the time. Closer to the mouth of the Creek, at Mulberry Landing, bacteria concentrations were far lower and only 6% of the samples failed to meet the safety standard. Since 2004, average annual

concentrations of *Enterococcus* bacteria at Old Mill Road bridge also have consistently remained above the long-term safe swimming standard, while the standard is generally met at the Mulberry Landing site (Figure 17). Dirickson Creek's bacteria concentrations have neither increased nor decreased significantly over time, but many areas routinely fail to meet standards for safe recreational use of the water.

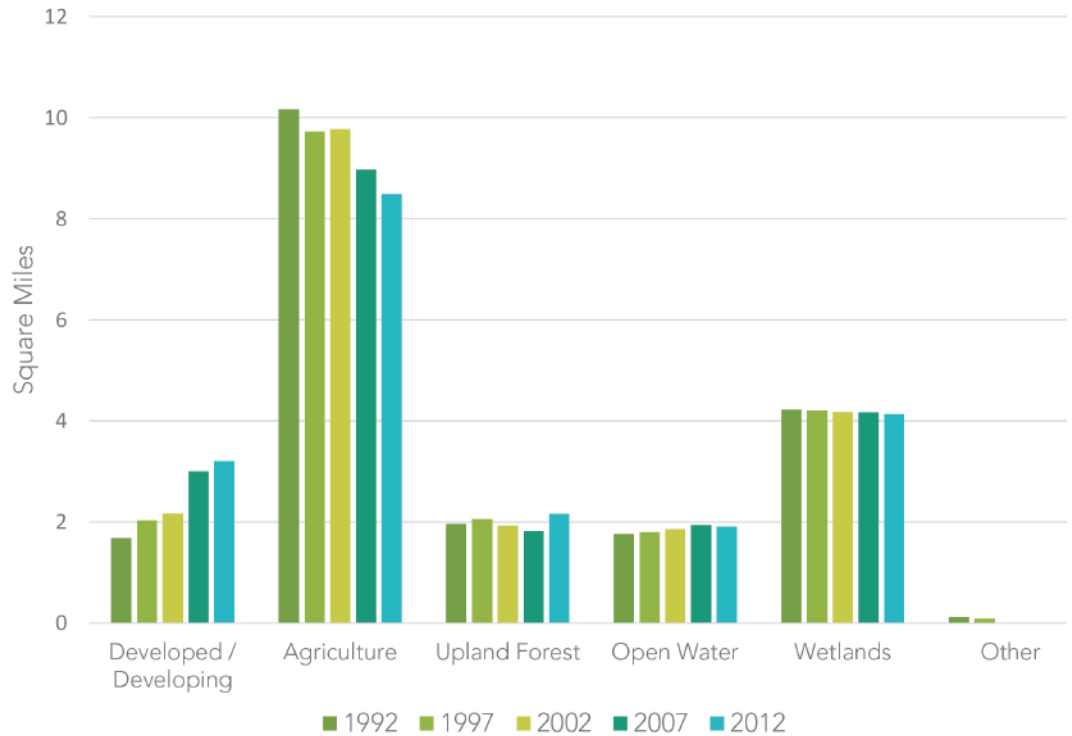
Figure A-2. Land use change in the Dirickson Creek watershed, 1992 – 2012.

Figure A-2 summarizes the changes across the six categories, within the Dirickson Creek watershed, for each of the five-year periods. The percent of land use for each broad category from 1992 was compared to the current percent in the 2012 land use data.

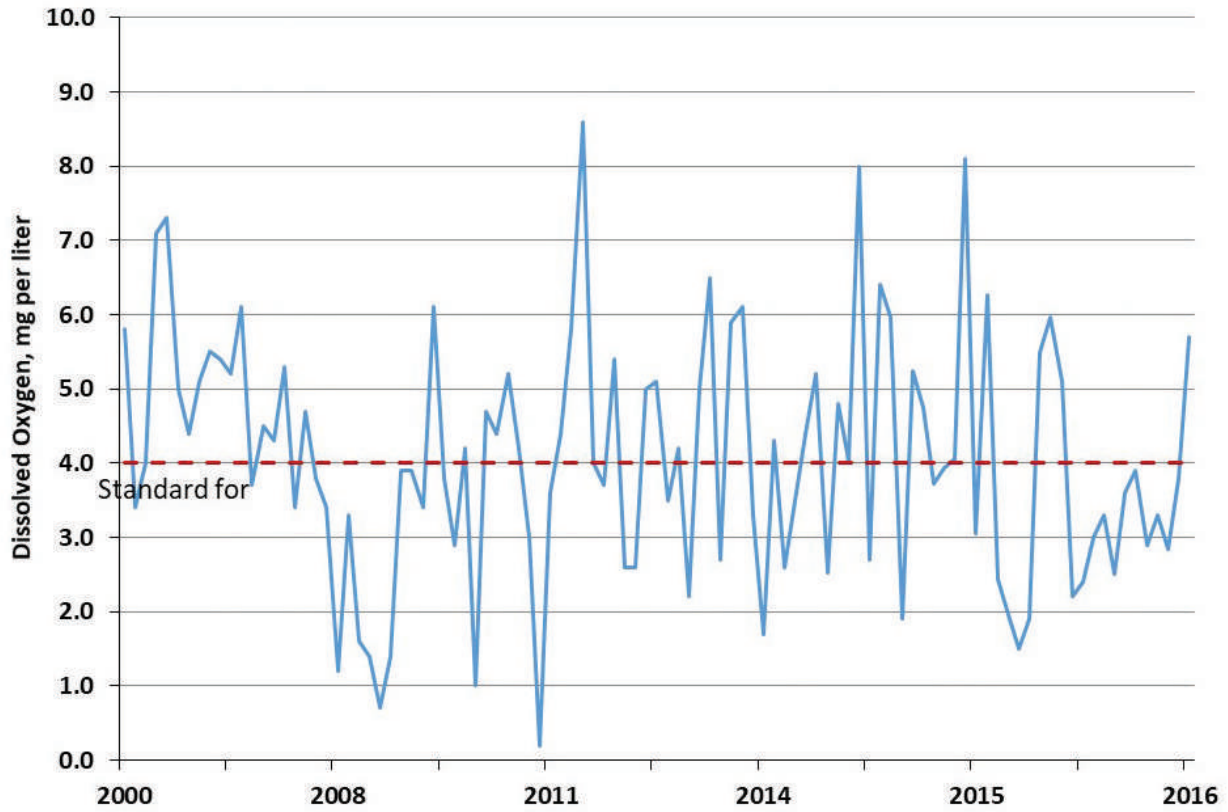
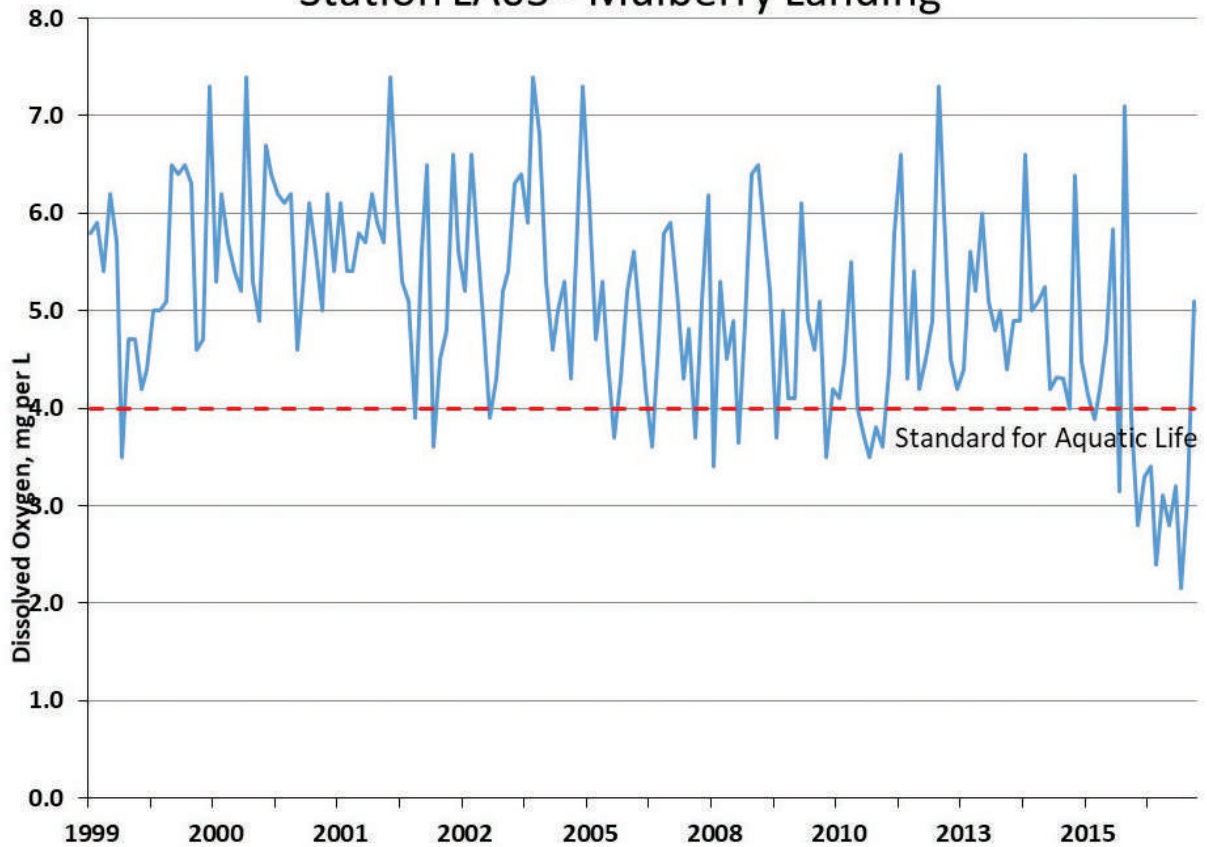
Station LA09 - Old Mill Rd Bridge

Figure A-3. Dissolved oxygen concentrations for each summer observation to better show the variability in samples.

For each month, the mean dissolved oxygen value was calculated for each station, and this monthly mean was plotted on the graph. It was found that 20 out of 44 (45%) monthly means fell below the water quality standard of 4 mg/L at LA09. 4 out of 72 (5%) monthly means fell below the 4 mg/L standard at LA03.

To provide further clarity, each individual observation was plotted and results are pictured below (Figure A-3). It was found that of the samples at LA09 that met the seasonal and time-of-day criteria (i.e., summer mornings), 51 out of 101 (50.5%) samples did not meet the water quality standard for DO of 4 parts per million (mg/L). At station LA03, 26 of 178 (14.6%) samples failed to meet this standard. These results are similar to the monthly mean results used in the report.
